Ten-Year Performance of Shell-Treated Wooden Deck¹

Jong Bum RA

Keywords: copper contamination, refractory species, surface checks, wooden deck

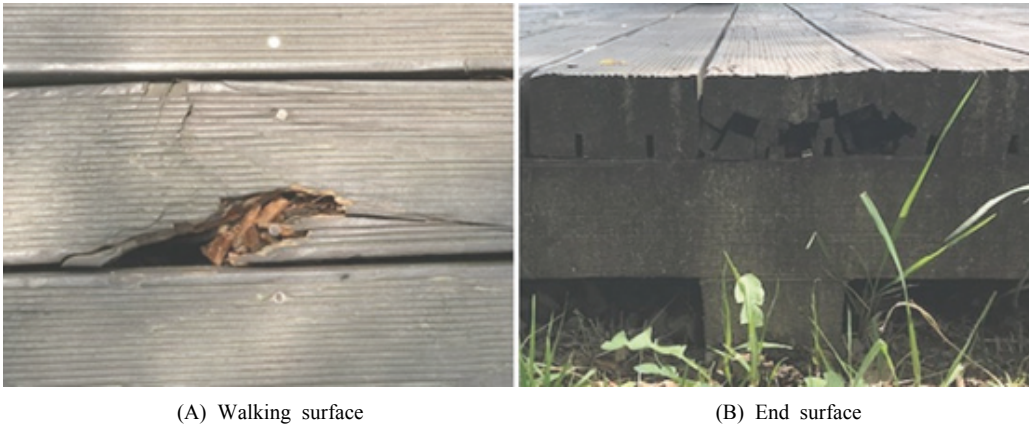
The decking board showed extreme graying from UV exposure, warping, checking, splitting, and decaying.

The deck boards seemed to be treated with oil stain once. However, the end surfaces of many deck boards were not treated sufficiently with wood preservatives, which resulted in severe decay (Fig. 2). The decay ratings of the decking in Table 3 are the values of the decking unreplaced.

Fig. 2. Decking boards showing severe decay.

1. Severe decays were observed in the wooden deck, which can be explained by the failure to meet the minimum requirements for penetration and retention for treated wood.
2. Decay usually occurred in the end surface of the treated wood, which means that the end surface must be treated with wood preservatives.
3. The shell-treated wood without deep checking showed no heavy decay, suggesting that a design approach to minimize checking and splitting would be needed to increase the service life of the shell-treated wooden deck.
4. There is little concern about the environmental pollution of copper depleted from the treated wooden deck.

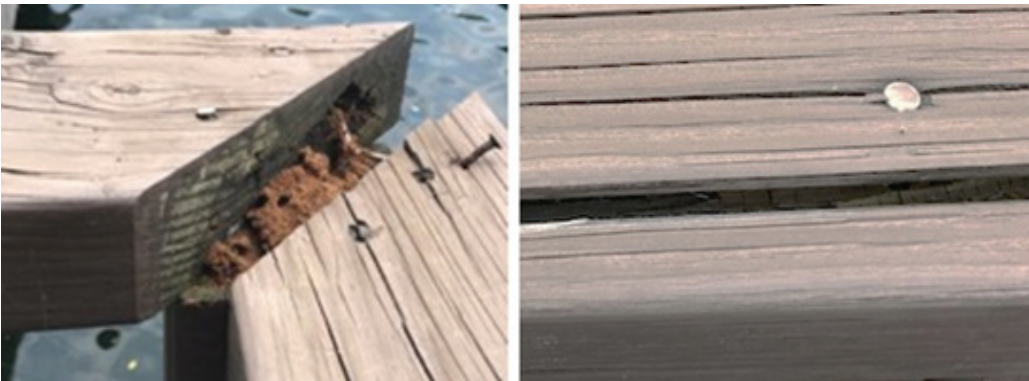
The inspection of the deck rails showed that the cap rails were under severe checking, splitting, and decay (Fig. 3). However, other treated members such as posts, top rails, base rails, and balusters had only limited decay in a few members and were not in danger of falling.

Severe decay in the cap rails can be explained by the poor penetration and retention, the occurrence of deep checking or splitting, and the exposure of untreated end surface (Fig. 3). The end surface, if cut to expose

Fig. 3. The decayed parts of the cap rails.

new wood, must be treated by brush or spray application with wood preservatives. Domestically this is often overlooked, resulting in the severe decay.

To minimize the occurrence of deep checking can be a useful way to prevent the wood from decaying. The number and size of the checking that generally roles as water path were remarkably larger and bigger in the cap rails than in the top and base rails and the balusters. The phenomena may be explained by both the larger width of the cap rails and the relatively more amount of direct contact of rain and sunshine. Checks occur when the drying stresses that develop in the outer part of wood exceed the tensile strength of the wood.
