Species Identification and Tree-Ring Dating of the Wooden Elements Used in Juheulgwan of Joryeong (Gate No.1), Mungyeong, Korea¹

This study's objective was to conduct species identification and tree-ring dating of wooden elements used in Mungyeong Juheulgwan of Joryeong (Gate No. 1). Of the 84 wooden elements evaluated, 76 were confirmed to be hard pines, 5 were soft pines, and 3 belonged to *Abies* spp. For tree-ring dating, cores of the wooden elements were collected using a drill, and ring-width plots of individual samples were constructed using the TSAP software. The results of performing tree-ring dating for the outermost ring of 59 hard pine wooden elements revealed the following 4 felling dates: summer of 1708–late fall of 1709, summer of 1792–early spring of 1794, late fall of 1838–early spring of 1840 and 1867, and early spring–fall of 1872. These felling dates were found to be consistent with those in the construction and repair records of the Annals of Joseon Dynasty, Juhulgwan Jungsugi, and those engraved on Juhulgwan Walls. It is believed that some of the wooden materials harvested at that time were stored and used since there was a difference of approximately 10 year

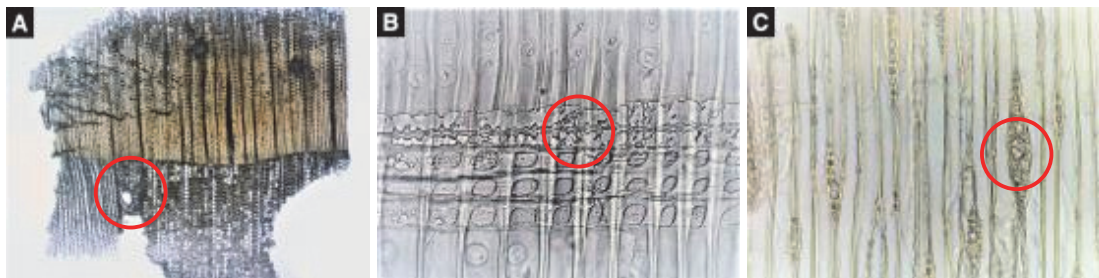
Fig. 2. Micrographs of Hard pine species (A=Cross section ($\times 40$), B=Radial section ($\times 400$), C=Tangential section ($\times 200$)).

This softwood undergoes a rapid transition from earlywood to latewood. Vertical vessels with thin-walled epithelial cells were observed under optical microscope. The ray cells were composed of ray parenchyma and

ray tracheid, and one window-like pit was observed in the cross-field. Particularly, dentate thickening, which is the main feature of hard pines belonging to the *Pinus* spp., was observed in the ray tracheid. In the longitudinal ray tracheid, an arrangement of bordered pits was observed in one row. In the tangential section, horizontal vessels were observed, and uniseriate and fusiform ray cells were also observed (Fig. 2). Within the *Pinus* spp., hard pines and soft pines exist, and the sample was finally identified as hard pine since

dentate thickening was observed.

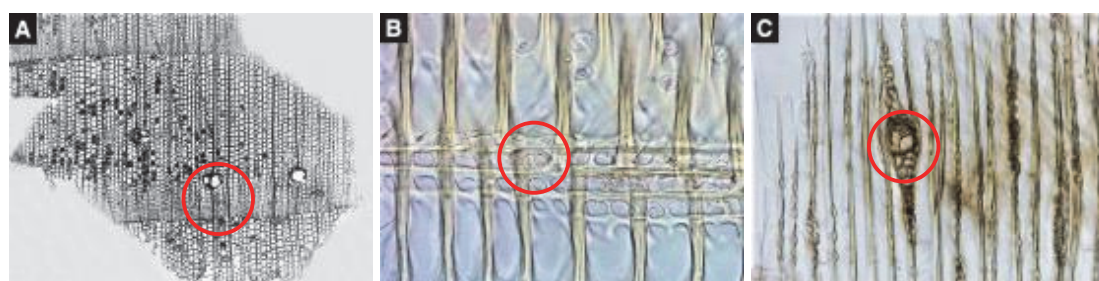
Fig. 3. Micrographs of Soft pine species (A=Cross section ($\times 40$), B=Radial section ($\times 400$), C=Tangential section ($\times 200$)).

This is a hardwood that undergoes a slow or slightly rapid transition from earlywood to latewood. When viewed under optical microscope, vertical vessels with thin-walled epithelial cells were observed. The ray cells consisted of ray parenchyma and ray tracheid, and two window-like pits of one were mainly seen in the observation field. Unlike the hard pines that belong to the *Pinus* spp., dentate thickening was not observed in the ray tracheid. A one-row arrangement of bordered pits was observed in the longitudinal ray tracheid. In the tangential section, horizontal vessels were observed. Additionally, both uniseriate and fusiform ray cells were observed (Fig. 3). The *Pinus* spp. consist of both hard and soft pines; however, since dentate thickening was not observed, the sample was finally

identified to be soft pine.

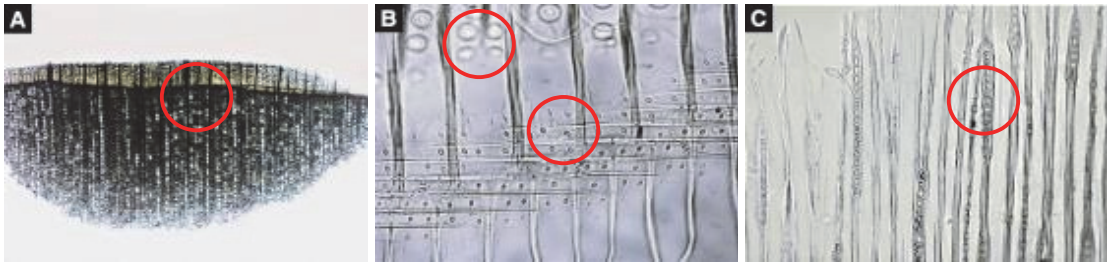
Fig. 4. Micrographs of *Abies* spp. species (A=Cross section (×40), B=Radial section (×400), C=Tangential section (×200)).

This is a softwood that undergoes a gradual transition of tracheids from earlywood to latewood. No normal resin canals were observed in the prepared cross-section. The ray cells comprised only of ray parenchyma, and the horizontal wall of the ray parenchyma had well-developed simple pit pairs and modular end walls. In the cross-field, 2-3 taxodioid pits were observed. The bordered pits in the longitudinal ray tracheid were arranged in one or two rows. No horizontal vessels were observed in the tangential section, and only uniseriate rays were observed (Fig. 4). The *Abies* spp. distributed in Korea consists of three species, namely, *A. holophylla*, *A. nephrolepis*, and *A. koreana*; however, since they are anatomically indistinguishable, the sample was finally identified as *Abies* spp.

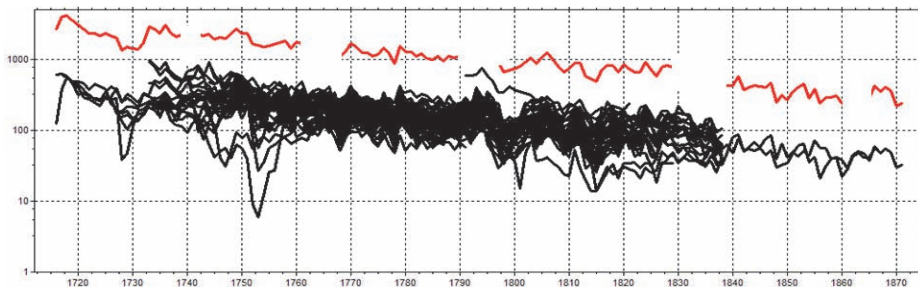
Fig. 5. The Joryeong chronology (JRPD 1S) made from wood elements of Juheulgwan (red graph: the Joryeong chronology, under graph: chronology of 54 wood elements).

Among the 84 samples obtained from the gatehouse and side doors of Mungyeong Juheulgwan of Joryeong, 76 samples of hard pine, excluding the 5 samples identified as soft pine and 3 samples identified as *Abies* spp., were included for further analysis. Among the 76 samples, 54 were similar to each other, creating Chronology 1 (Joryeong 1S; Fig. 5). The tree-ring pe-

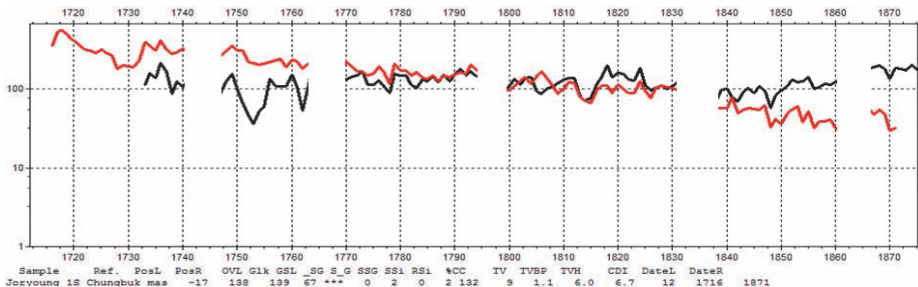
Fig. 6. The Joryeong chronology (JRPD 1S) cross-dated with master-chronology (red graph: JRPD 1S, black graph: master-chronology).

riod was 157 years, and to find out the exact year, cross-dating was conducted using the standard chronology of hard pine owned by the Korea National University of Cultural Heritage. On analysis, the t-value was found to be 6.7, and the G-value was 67%, which was a relatively high statistical value and graphically consistent (Fig. 6). Therefore, Mungyeong Juheulgwan of Joryeong (Gate No.1) hard pine Chronology 1 (Mungyeong 1S) was dated as 1744–1869. Among the

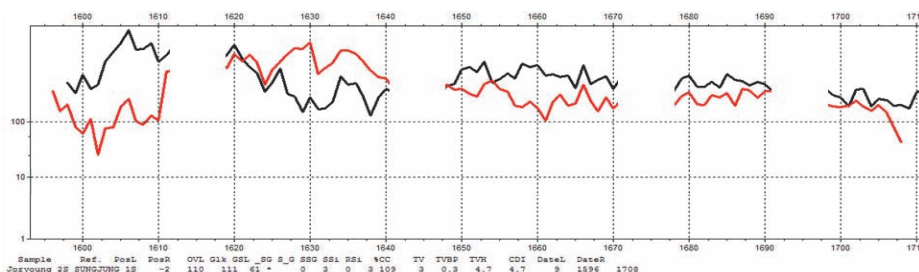
Fig. 7. The Joryeong chronology (JRPD 2S) cross-dated with master-chronology (red graph: JRPD 2S, black graph: master-chronology).

wooden elements included in the chronicle, it was validated that wood harvested from the summer of 1792 to the early spring of 1794 was used for some pillars, groves, and sangyeons with bark, and most of the elements were made from wood harvested from the late autumn of 1838 to the early spring of 1840. Additionally, it was confirmed that the timber for the unknown floor element 1 and the unknown roof element 3 were felled between the early spring and autumn of 1867 and 1872, respectively. Furthermore, the floor joists and five joists were similar to each other, thereby creating Chronology 2 (Joryeong 2S). The tree-ring period was found to be 113 years, and on performing cross-dating using the hard pine standard chronology, the statistical values of t-value (4.7) and G-value (61%) were found to be graphically consistent. Therefore, Mungyeong Joryeong Gwanmun Gate 1 (Juheulgwan) hard pine Chronology 2 (Joryeong 2S) was dated as 1596–1709 (Fig. 7). Two of the elements involved in the chronicle (floor joists 2 and joists 2) had bark; therefore, it was confirmed that they were felled between the summer of 1708 and late autumn of 1709.

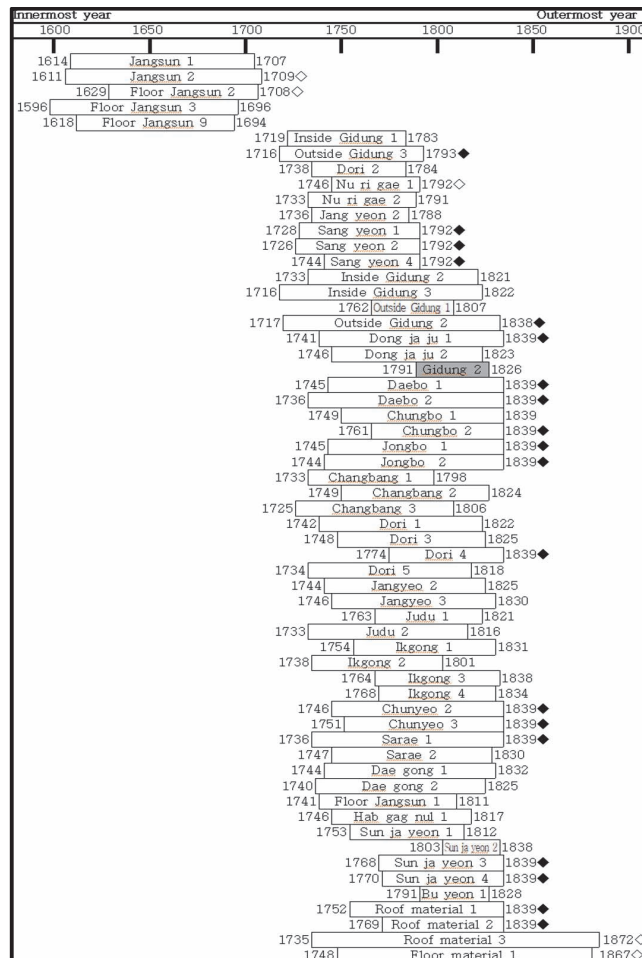
Fig. 8. Dendrochronological dates of individual wood elements included in Joryeong chronologies (◆ indicated the outermost annual rings that are just below barks and have completed latewood formation; ◊ indicated the outermost annual rings that form earlywood; : Side door material).

59 of the 76 hard pines analyzed, and 4 felling dates were identified. It was confirmed that the joist members of the floor were felled between the summer of 1708 and late autumn of 1709, and thus were considered to be early construction members. Most of the other members were felled throughout one and a half years, from late autumn of 1838 to early spring of 1840, and it is believed that large-scale repairs were carried out 130 years after the construction. Additionally, it is believed that some of the outer columns, nurigae,

and sangyeon were felled between the summer of 1792 and the early spring of 1794, showing that repairs and replacements of some members were carried out 150 years after the large-scale repair. Afterward, it was confirmed that a floor member, presumed to be a dongbari, and one unidentified roof member each were felled in 1867 and 1872, suggesting that after 1872, a simple repair was carried out on the floor to replace some decomposed parts with dongbari, in addition to carrying out repairs on the roof (Fig. 8).
