A Study on the Tool-Trace of Wooden Storage Facilities in Sabi Baekje through the Reproduction Experiments: Focusing on the Adze, Chisel, and Saw

This study was conducted to reproduce the woodworking process of Baekje wooden storage facilities. Green timber of *Quercus* spp. was processed using ancient woodworking tools, and the tool-trace formed in this process were compared with the tool-trace of actual excavated artifacts. In the tool-trace analysis, the length and shape of the tool-trace were objectively recorded using a 3D Scan, and that were difficult to confirm with photograph were confirmed through stereoscopic microscope. As a result, there were two types of adze's tool-trace. One of them is minute straight Blade-top trace line when trimming the wood surface and the other is Plucked trace that appear when strongly chop at the wood. When a chisel bat was not used, a long and wide continuous shape blade trace was produced. And when the chisel head was struck with the chisel bat, a straight blade-top trace was regularly observed. Saw-trace was identified in several layers with fine straight stripes. Through this, it was found that the tool-trace of the woodworking tools, whi

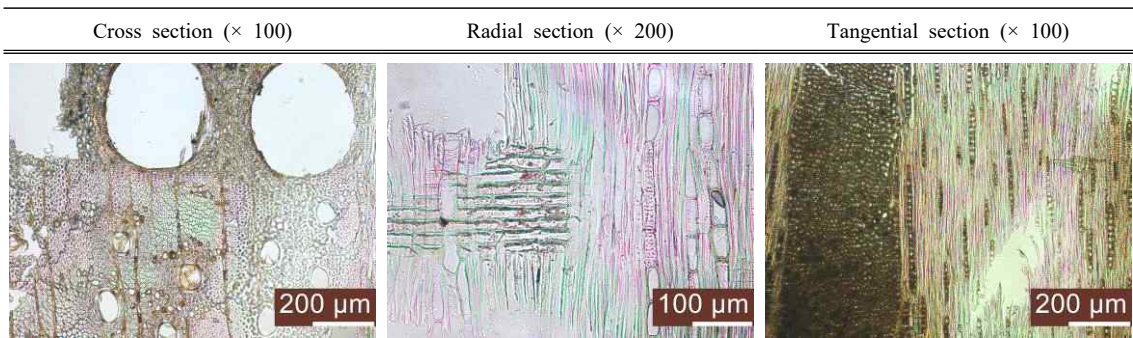
Table 1. Micrographs of subject

The wood was classified as ring-porous wood, belonging to the hardwood category, with pore zones isolated in 1–2 rows. Vessels were arranged radially with circular perforation plates. Longitudinal parenchyma cells were arranged in diffuse or short tangential bands, and the medullary rays were homogeneous. Broad rays and compound rays were observed together, confirming the presence of compound rays. Based on the observation that the vessels have circular to oval perforation plates and the presence of ring-porous characteristics within the genus *Lepidobalanus*, the wood was identified as the *Lepidobalanus* genus, commonly known as oak. While both *Quercus acutissima* and *Quercus variabilis* exist

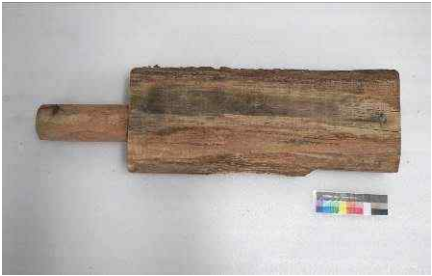
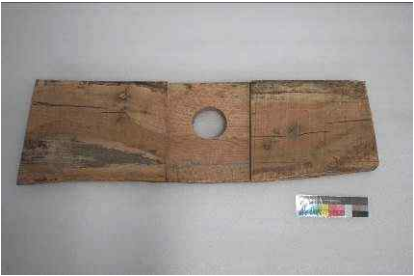
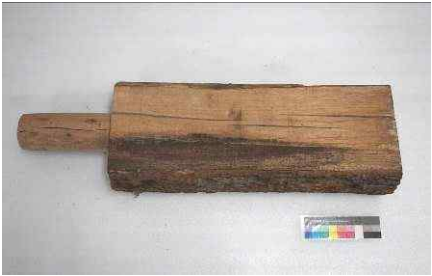
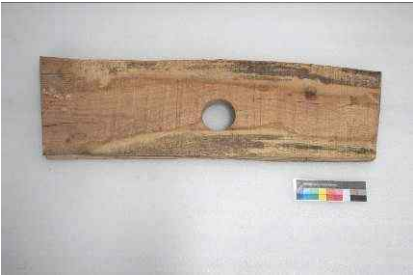
Table 7. Completed appearance of reproduction components

were drilled using chisels and then refined. Additionally, to ensure that the tenons fit securely into the mortise holes, half-lap joints with a height of approximately 20 mm were chiseled to completion (Table 6). The completed components, including tenons and mortise holes on plank-shaped components, are illustrated in Table 7.

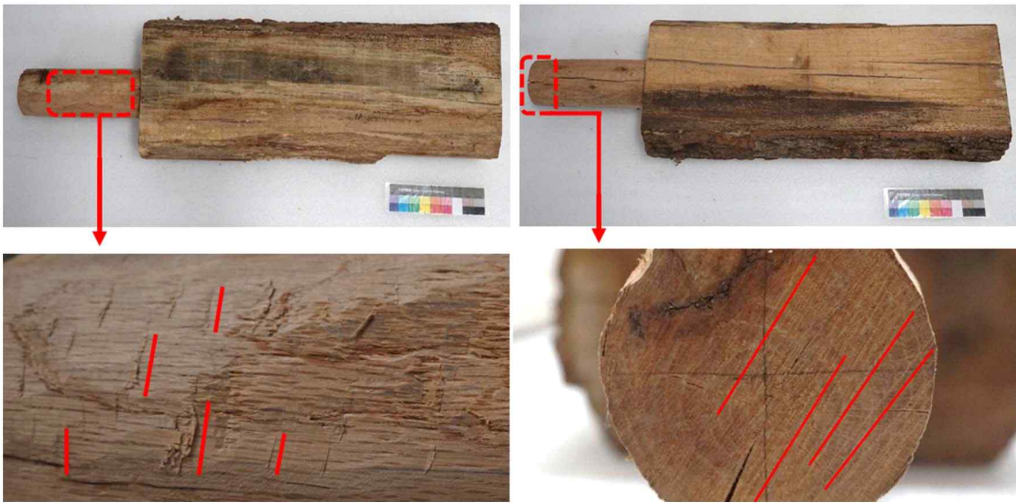
length, were observed. Additionally, diagonal continuous saw traces, resulting from the sawing motion, were observed on the transverse section of the tenon, along with indentations of approximately 35 mm caused by chisels during the process of shaping the tenon into a cylindrical form (Fig. 1). When classifying these tool traces according to the skill level of the craftsmen, noticeable differences were observed between the adze traces of novices and those of skilled craftsmen. Novices' adze traces appeared less uniform, with numerous plucked traces observed overall, while skilled craftsmen's surfaces appeared smoother, with only a few adze traces remaining (Fig. 2).

Fig. 1. Tool-trace reproduction tenon front and rear photograph. Chisel-trace and saw-trace enlargement.

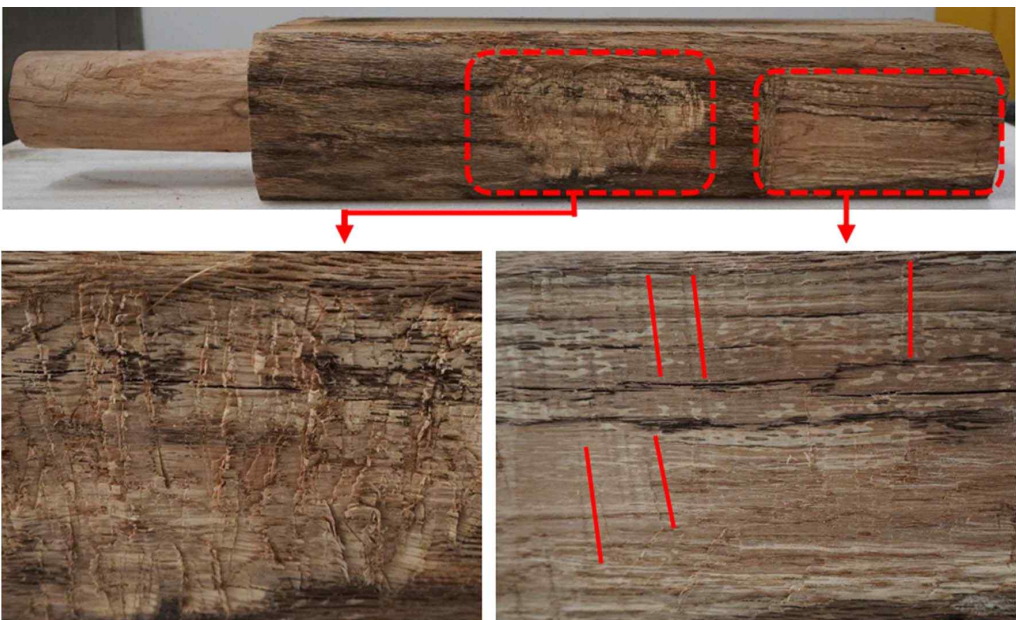
Fig. 2. Tool-trace reproduction tenon aspect photograph. Adze-trace (unskilled) and adze-trace (skilled) enlargement.

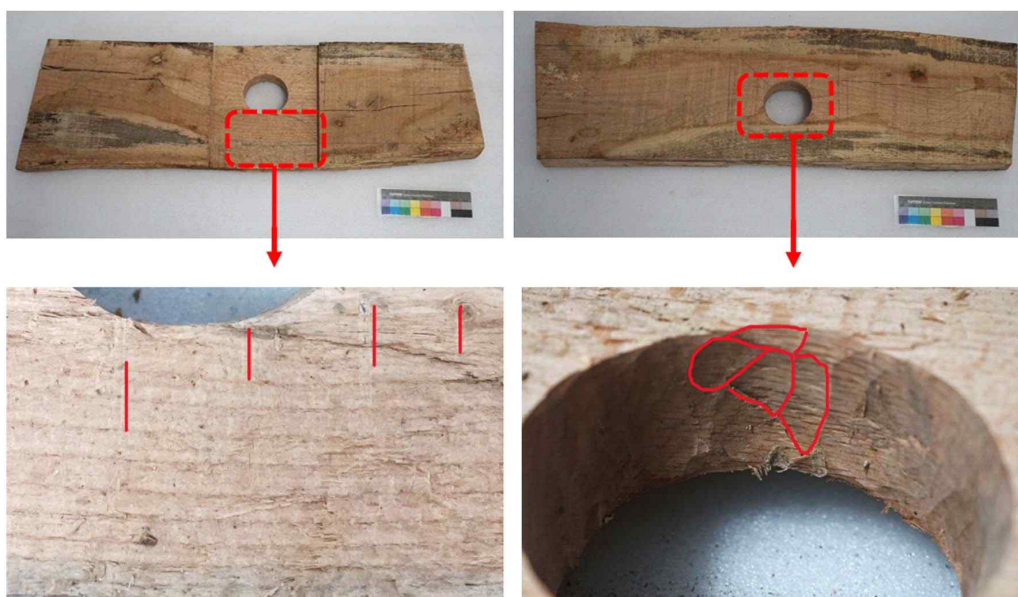
primarily utilized for flattening the surface of the plank components. Additionally, continuous chisel blade traces were observed in the mortise holes (Fig. 3).

Fig. 3. Tool-trace reproduction mortise front and rear photograph. Adze-trace and chisel-trace enlargement.

Upon comparing these results with actual artifact photographs, similar to the tenon components, it was observed that the tool traces on the actual artifacts appeared more distinct. This was interpreted as being due to differences in the tools used and variations in the completeness of the fabrication process, as was the case with the tenon components.

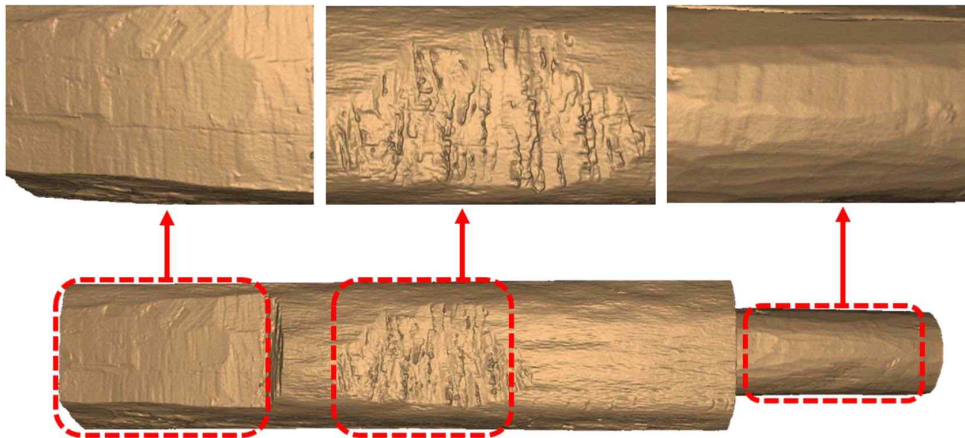
In the 3D scan results of the tenon components, observations of adze traces revealed significant differences between novice and skilled craftsmanship. Novice adze traces exhibited numerous plucked traces and some delamination of surrounding wood fibers. In contrast, skilled adze traces showed smooth blade traces of approximately 60 mm in length, accompanied by continuous chisel blade traces, without any noticeable delamination of wood fibers. This suggests that utilizing 3D scanning allows for clearer observations of continuous chisel blade

traces compared to photographic methods. Additionally, chisel traces, which were challenging to capture accurately due to variations in lighting and angles in photographs, could be accurately recorded through 3D scanning (Fig 4). Finally, saw traces appeared as continuous surface scratches, enabling approximate determination of the saw's cutting direction (Fig. 5)

Fig. 4. Tool-trace reproduction tenon 3D scan data. Adze-trace (skilled) and adze-trace (unskilled), chisel-trace enlargement.

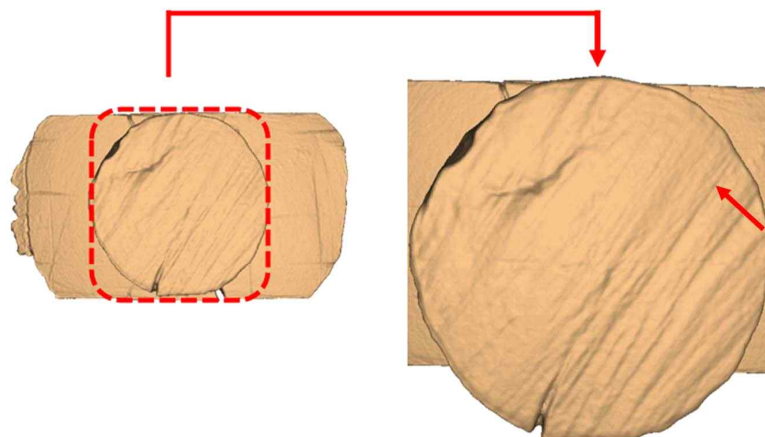
Fig. 5. Tool-trace reproduction tenon 3D scan data. Saw-trace enlargement.

3. Saw traces appeared as multiple layers of straight lines, allowing for the inference of the approximate cutting direction. However, due to the overlapping nature of saw cuts, it was difficult to determine endpoints, posing challenges in estimating the length of saw blades.

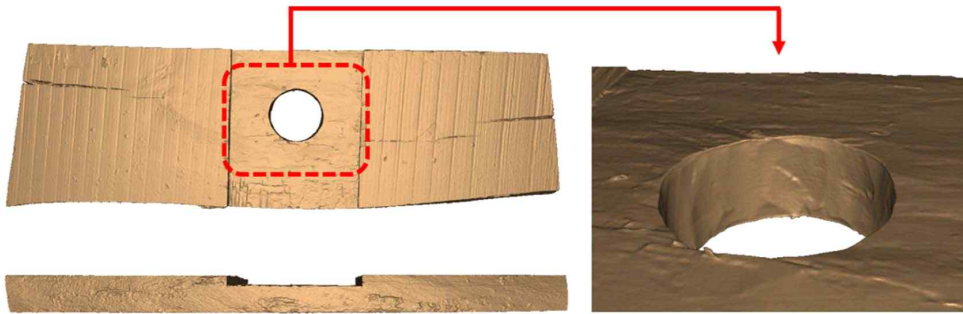
The 3D scan results of the plank components revealed similarities in overall surface machining results compared to the tenon components. However, differences were observed in the areas where chisels were used. In the tenon components, faint blade traces of approximately 35 mm and continuous chisel blade traces were visible. In contrast, blade traces were challenging to observe in the plank components, and the chisel blade traces appeared relatively broader compared to those in the tenon components (Fig. 6). This difference is attributed to the restricted range of motion and tool usage when machining the mortise holes in the plank components, as oppo-

Fig. 6. Tool-trace reproduction mortise 3D scan data and the enlargement of the chisel-trace.

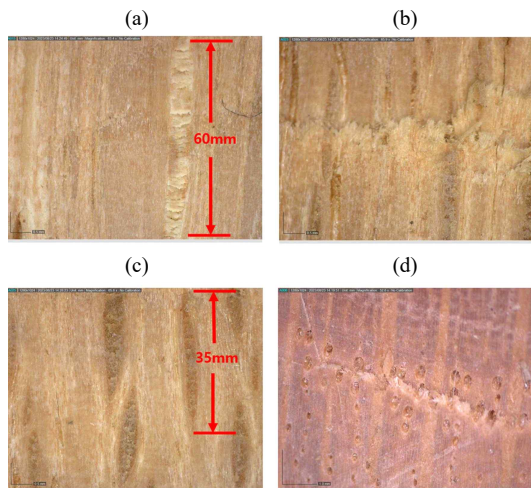
Microscopic examination of adze and chisel blade traces on both tenon and plank components revealed interesting findings. Adze blade traces exhibited approximately 60 mm of fiber breakage traces. Similar to the

3D scan results, adze blade traces were found to vary depending on the impact angle and the skill level of the craftsman, sometimes forming plucked traces and sometimes leaving only blade traces [Fig. 7(a) and (b)].

On the other hand, chisel blade traces showed approximately 35 mm of faint blade traces. When compared to adze blade traces, chisel blade traces exhibited a similar pattern even under microscopic examination

[Fig. 7(c) and (d)]. Therefore, distinguishing between adze and chisel blade traces based solely on their appearance might be challenging. However, considering the width of the blade, it is possible to differentiate between them based on the length of the blade traces. Additionally, like the 3D scan results, it was observed that there were variations in the residual traces depending on the direction of chisel movement (parallel or perpendicular to the wood fibers). This study found that estimating the blade width of the woodworking tools used during production is possible through the analysis

Fig. 7. Micrographs of tool-trace. (a) Adze blade-top trace, (b) adze plucked trace, (c) chisel blade top-trace, (d) chisel plucked trace.

the direction of chiseling. When chiseled in the direction of the grain, shallow blade traces in a straight form continuously remained, whereas when chiseled perpendicular to the grain, distinct scraping marks remained. Chisel blade-top traces closely resembled adze blade-top traces, making it possible to distinguish them through the width of the blade.
