Ten-Year Performance of Shell-Treated Wooden Deck¹

Jong Bum RA

Keywords: copper contamination, refractory species, surface checks, wooden deck

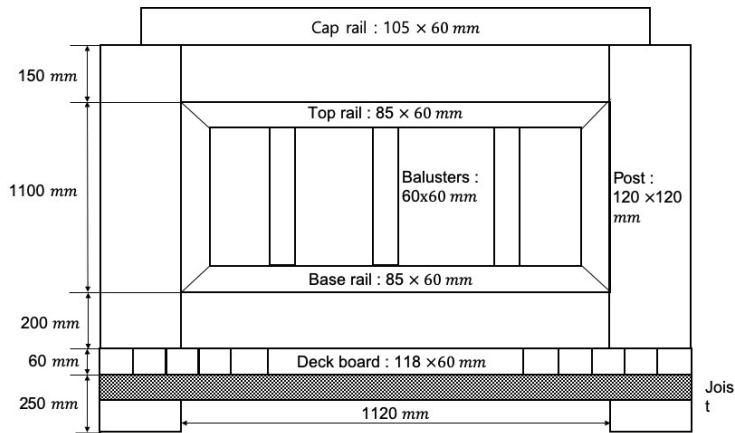
Fig. 1. The structure of the wooden deck.

The deck was exposed to heat, cold, ice, water, wind, and UV exposure with no periodic treatment with oil stain. The deck boards and the railings showed decay, checks, and splitting.

were already replaced because of severe decay. The cap rails showed much more severe decay in progress than the top and the base rails. However, the posts showed only limited decay in a few and were not in danger of failing (Table 3).
