Analysis of Airtightness and Air Leakage of Wooden Houses in Korea¹

ABSTRACT

Airtightness of buildings is one of critical aspects of its energy performance. To build up references of airtightness of wooden houses built in Korea, blower door tests have been carried out in 42 houses since 2006. Causes of air leakage were investigated recently. The average value of air change rate was 3.7 h⁻¹ for light frame house and 5.5 h⁻¹ for post-beam construction at ACH50 (air change per hour at 50 Pa air pressure difference). Foam type insulation was more advantageous in ensuring building airtightness than glass fiber batt. Airtightness of wooden houses which were constructed after 2010 was improved to have less than 1.5 h⁻¹ of ACH50, threshold for application of artificial air change. The average air change rate of CLT (cross laminated timber) houses showed the lowest value, 1.1 h⁻¹, among the tested structures.

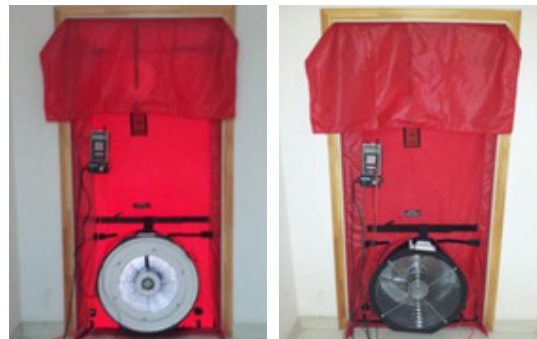
Fig. 2. Depressurization (left) and pressurization (right) mode of blower door test.

sulation, the pressurization and depressurization test mode was applied (Fig. 2).

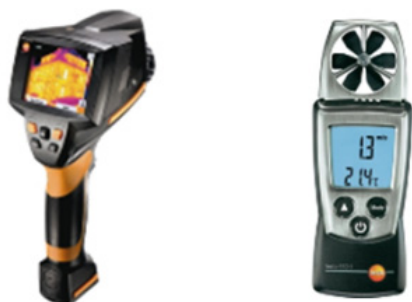
Fig. 3. Infrared camera (left) and vane anemometer (right).

In order to find out causes of induced poor building airtightness, infrared camera and vane anemometer were used (Fig. 3). The infrared

camera was used to inspect heat loss spot. The vane anemometer was used to confirm whether the heat loss was induced from air leakage or not.

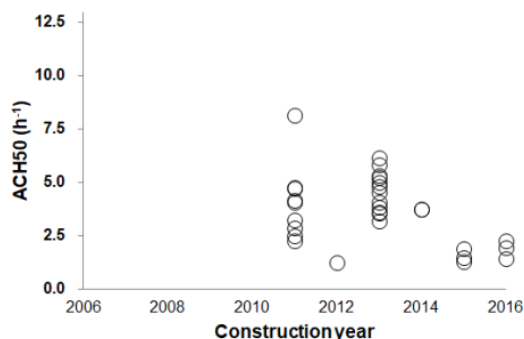
Fig. 4. Building airtightness change of light frame constructions.

The 30 measurements of building airtightness in light frame houses are shown in Fig. 4. Building airtightness by the construction year had improved gradually. Montoya *et al.* (2010) and Sinnott *et al.* (2012) had proved construction year as influencing variable. The air change rate values less than 1.5 h⁻¹ of ACH50 had appeared after 2012. The thermal trans-

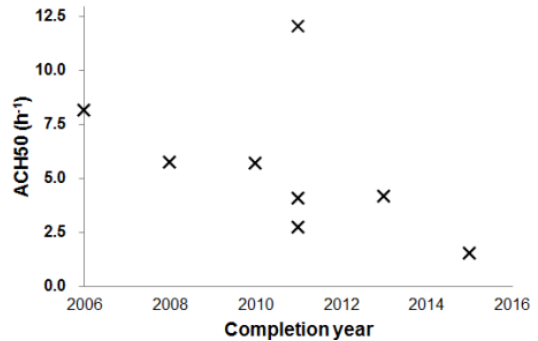
Fig. 6. Building airtightness change of post-beam constructions.

The 8 measurements of building airtightness in post-beam constructions are shown in Fig. 6. As same as light frame, building airtightness had improved gradually except only 1 measurement in 2011. This was obtained from an accommodation in public recreational forest. The highest value of ACH50 in 2011 of light frame house in Figure 4 was also obtained at the same place. Because the accommodation was in public place, it was considered that there was less attention on the air tightness during construction of the house than private house. As a

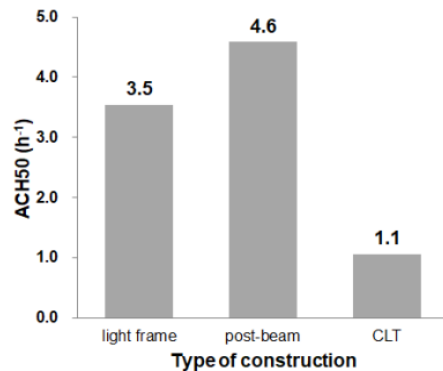
Fig. 7. Building airtightness difference by construction type.

Except 2 measurements with poor airtightness from public accommodation, the average values of ACH50 in light frame, post-beam and CLT constructions are compared in Fig. 7. The light

frame houses showed higher airtightness than post-beam construction. Most of post-beam constructions, air leakage was detected at the junctions of walls and post-beam members and the connections of post and beam (Fig. 8).

In the case of CLT houses, ACH50 of them were very low, 1.4 h⁻¹ and 0.7 h⁻¹. The 0.7 h⁻¹ of ACH50 was the smallest value among all of the tested houses. Although building airtightness is affected by various factors, it was clear that CLT construction in Korea was advantageous to keep building airtight.

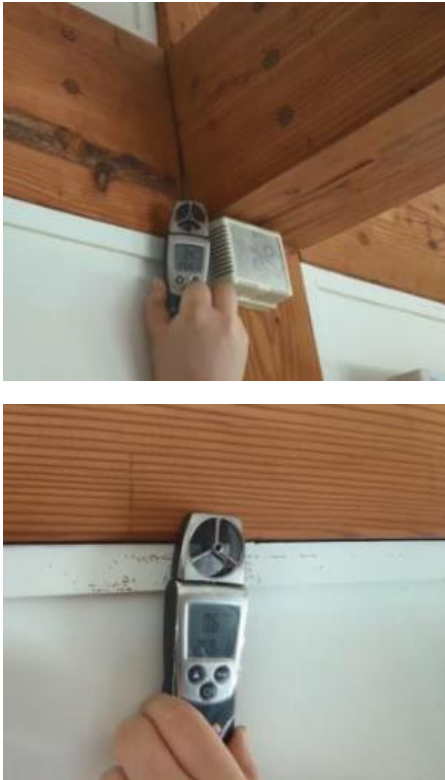
Fig. 8. Air leakage in post-beam construction.

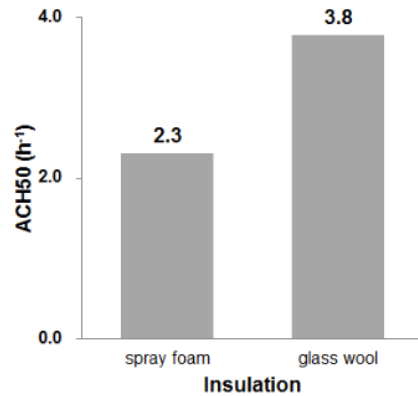
Fig. 9. Comparison of building airtightness of glass wool insulation vs foam type insulation.

Glass wool has been used as common insulation material in most of wooden houses in Korea. The use of spray foam type insulations, such as polyurethane foam, is increasing not only because of installation convenience but because of advantage of airtightness. Among the 42 tested houses, 37 houses used glass wool and the others did polyurethane foam as insulation material. As shown in Fig. 9, spray foam insulation appeared to be more favourable to improve building airtightness than glass wool. Because of unintended gaps while fitting glass wool into wall cavity and deflection of glass wool after fitting, glass wool dose not

have advantage on building airtightness. But, spray foam insulation can do the role of air barrier with flexibility of spraying and rigidity after hardening.

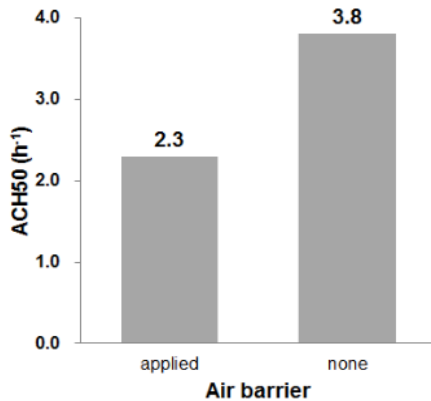
Fig. 10. Effect of air barrier on building airtightness.

Recently, the use of air barrier has increased for building airtightness in wooden house in Korea. Use of membrane for building airtightness is well known to be effective (Langmans *et al.*, 2010). 5 houses were installed air barrier at the wall assembly. As shown in Figure 10, the use of air barrier was effective on building airtightness. In case of the 3 houses with air barrier built in 2011, those building airtightness were improved than that of the other 5 houses with no air barrier, even though the houses were constructed at the same site and the same time by the same site manager. With considering time and cost for application of air barrier, unless passive house-level airtight performance

(below 0.6 h^{-1} of ACH50) is required, ensuring construction accuracy is more efficient than install of air barrier. Because, there were 5 measurements of light frame houses with below 1.5 h^{-1} of ACH50 without air barrier.

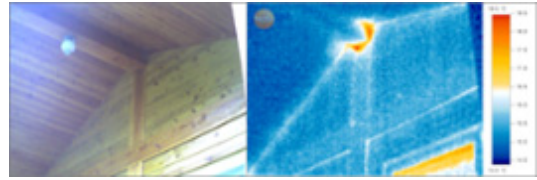
Fig. 11. Infrared image of air leakage of post-beam connection.

Fig. 11 shows the infrared image of heat loss induced by air leakage. Post and beam connections were weak area to prevent air leakage. Air leakage of post and beam connections can't be avoid because of dimensional variation of large scale structural members affected by surrounded hygro-thermal conditions.
